DOT/FAA/CT-88/20

Technology Assessment for Aircraft Command in Emergency Situations

October 1988

Final Report

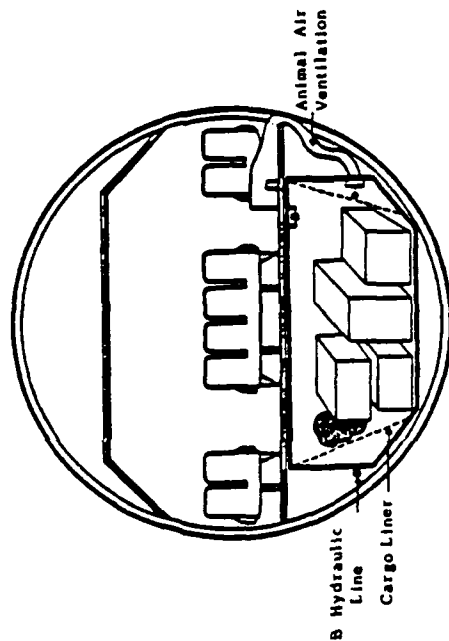
Background. This incident involved a serious fire in a baggage compartment in the aft section of a wide body tri-jet. The fire resulted in destruction of the aircraft; there were no survivors.

FIGURE 5A. FIRE STARTED FORWARD
LEFT SIDE AFT CARGO
COMPARTMENT

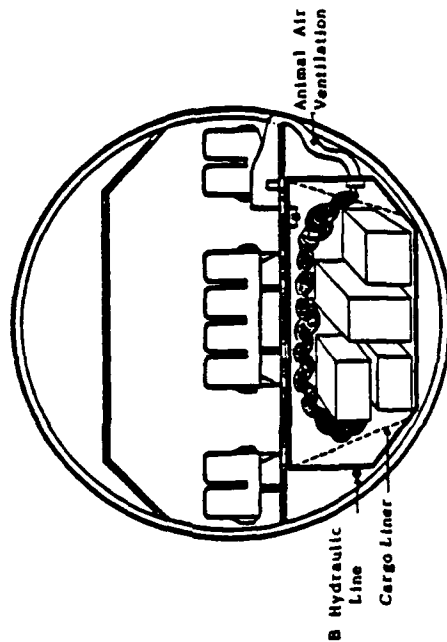
FIGURE 5B. SMOKE DILUTED BY AIR
VENTILATION SYSTEM

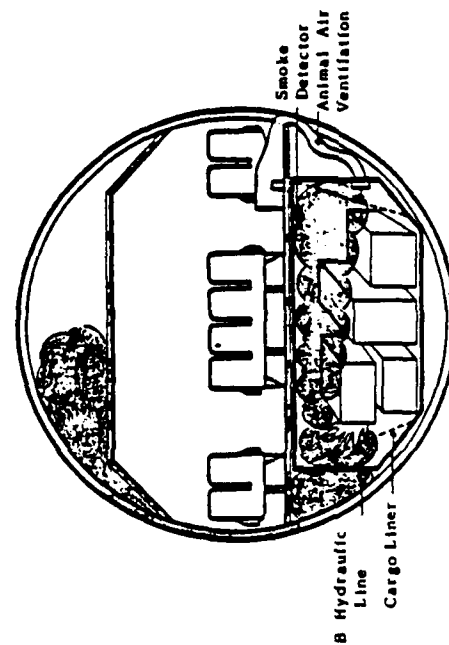
Detection of the Fire. The first detection was of smoke by an automatic smoke sensor which produced a visual and audible display in the cockpit. It

FIGURE 5C. SMOKE DETECTOR ALARMS,
FLAMES CONTACT LINER

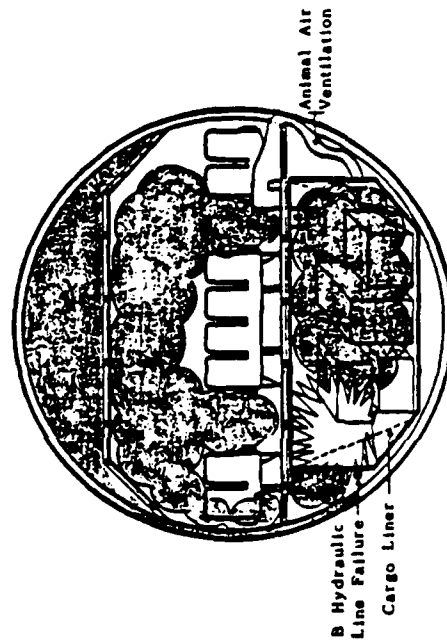
FIGURE 5D. B HYDRAULIC LINE FAIL-
URE CREATES SPRAY FIRE

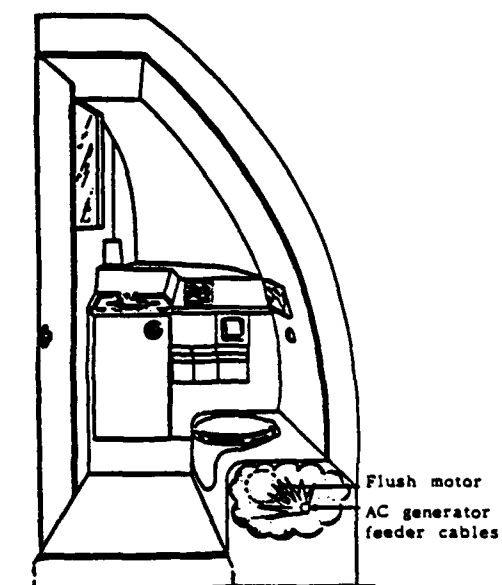
SCENARIO 2 - FIRE NARRATIVE. At approximately 1649, the fire began as a result of arcing of the AC generator feeder cables in and around the vicinity of the wiring harness to the toilet flush motor, left rear lavatory. At 1654 the flames from the burning debris and insulation burned through the flush motor wiring harness resulting in the simultaneous tripping of the circuit breakers for all three phases of the motor (Figure 7A). Smoke from this fire was distributed throughout the cheek area and above the passenger compartment as shown in Figure 7B. As the fire grew, it penetrated the amenities cabinet at the aft and the lower right hand corner, igniting stored amenities material such as bags and tissue. Because the air supply was limited to the small volume inside the amenities cabinet, the fire developed fairly slowly, but smoke began to drift into the lavatory itself. Although this smoke was initially drawn off by the sanitary ventilation system, the lavatory eventually filled with a light haze of smoke. At 1708, smoke drifted out of the cracks around the lavatory door and was first detected by a passenger who reported it to a Flight Attendant. It is estimated that the air temperature in the lavatory at this time was approximately 70°-80°F and the temperature inside the amenities compartment was between 100° and 200°F. The lavatory door was opened and within a minute a fire extinguisher was discharged and the lavatory door was closed again. Although the smoke seemed to be clearing in the passenger compartment, the fire grew inside the amenities cabinet, which caused the

FIGURE 7A. FLAMES CONTACT FLUSH MOTOR CABLES

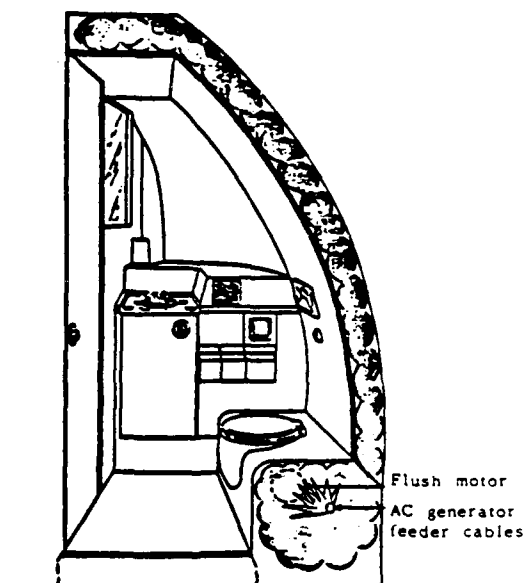
FIGURE 7B. SMOKE RISES INTO SIDEWALL AND OVERHEAD AREAS

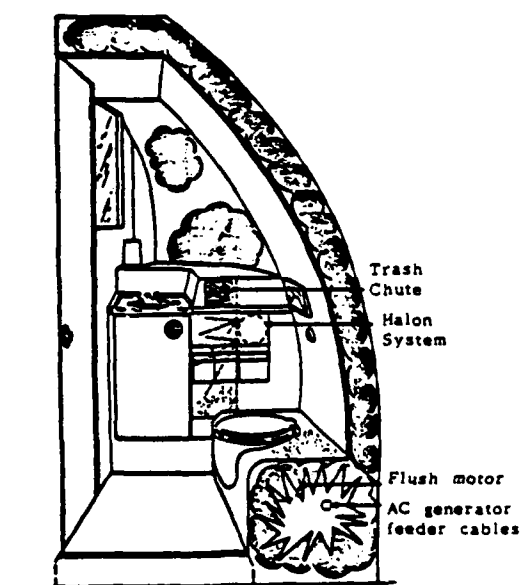
FIGURE 7C. GAS TEMPERATURE IN TRASH CHUTE TRIGGERS HALON SYSTEM

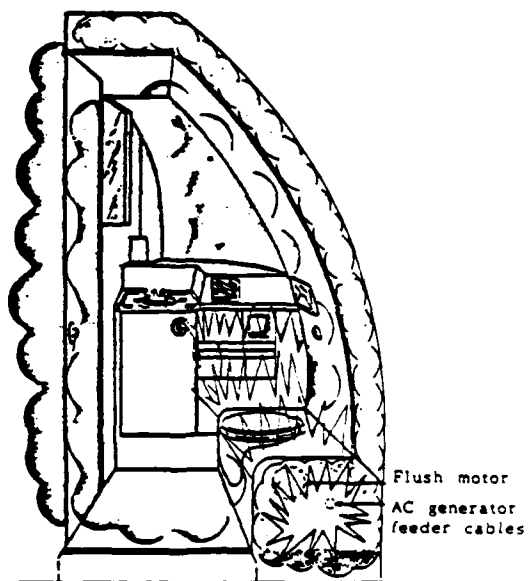
FIGURE 7D. FIRE PENETRATES WALL: SMOKE ENTERS PASSENGER CABIN

continued build up of smoke in the lavatory. At 1710, flames from the fire entered the lavatory. At 1711 the gas temperatures in the trash chute in the amenities compartment triggered the Halon system (Figure 7C). It is estimated that gas temperatures of approximately 250° F are necessary to operate the Halon system. The temperature rose rapidly in the lavatory, and, at 1712, it is estimated that it reached 400-500°F making the outside of the door too hot to touch. Somewhere between 1723 and 1728 the fire penetrated the lavatory wall exposing the passenger compartment to large quantities of black smoke and heated gases (Figure 7D). Temperatures at this time were between 1,000°F and 1,200°F in the lavatory. At 1730, the aircraft rolled to a stop and the doors were opened. One minute later there was a flashover which began in the rear of the cabin and moved forward, engulfing the entire cabin. The smoke-temperature signatures are shown in Figure 8.

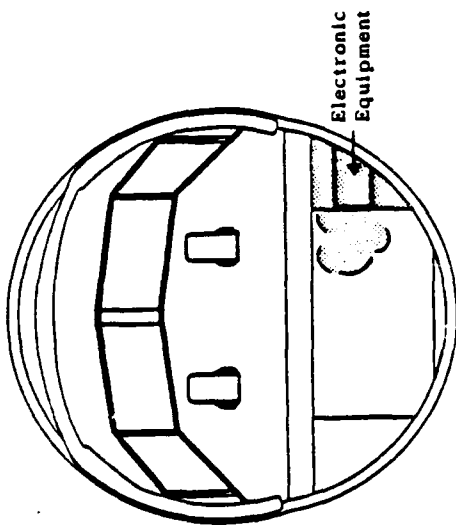
Detection of the Fire. Initial detection in this incident was by the odor of smoke in the cockpit and then by a compartment smoke detector and the appearance of smoke on the flight deck almost simultaneously. Detection most likely occurred very soon after the overheat began to produce smoke.

FIGURE 9A. SMOKE ACCUMULATES IN
EQUIPMENT CABINET

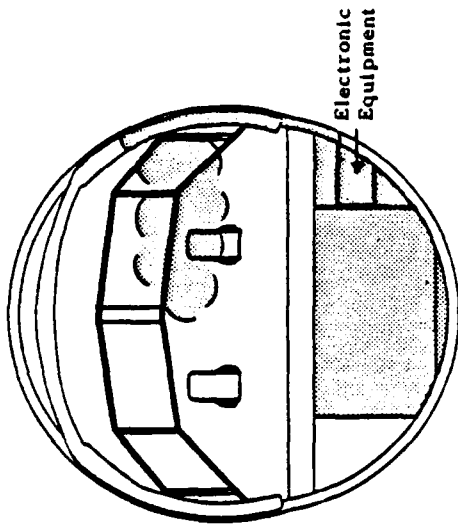
FIGURE 9B. SMOKE ACCUMULATING IN
COCKPIT

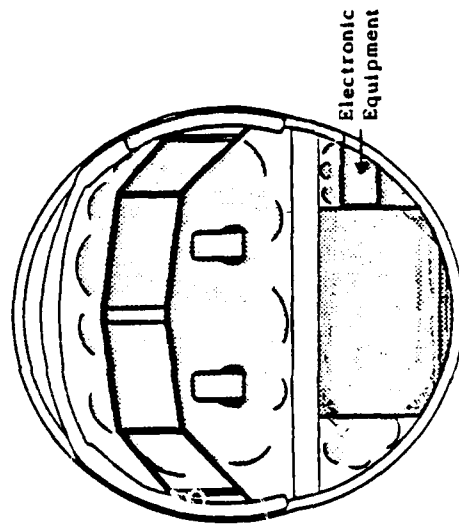
FIGURE 9C. SMOKE IS HEAVY IN
COCKPIT, FILLS AVIONICS
BAY

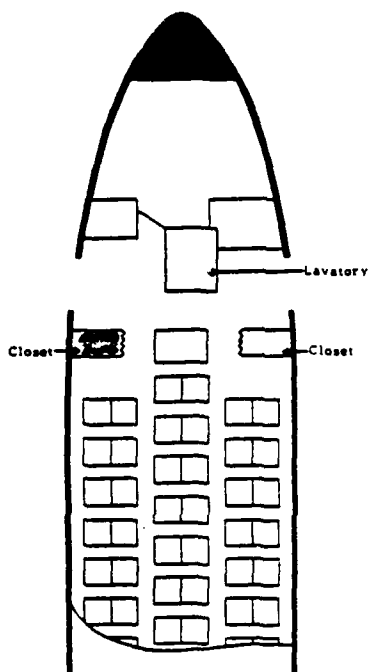
Detection of the Fire. Initial detection was by a passenger who smelled smoke; an Attendant investigated and found smoke issuing from the closet. This initial detection took place when the fire had smoldered for a relatively long time. Smoke and/or heat detectors in the closet would have probably detected the incident sooner.

FIGURE 11A. SMOLDERING FIRE
IN CLOSET

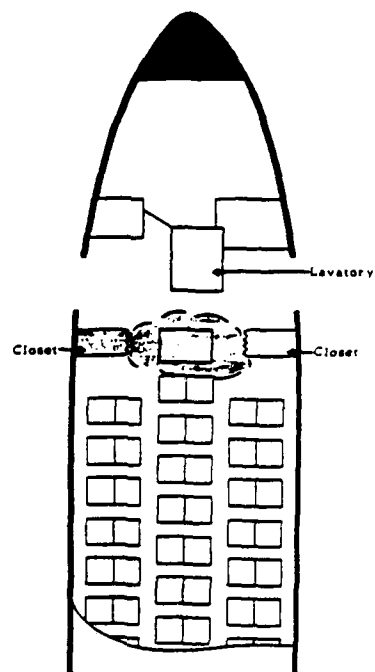
FIGURE 11B. SMOKE LEAKS FROM
CLOSET, IS DETECTED IN
PASSENGER CABIN

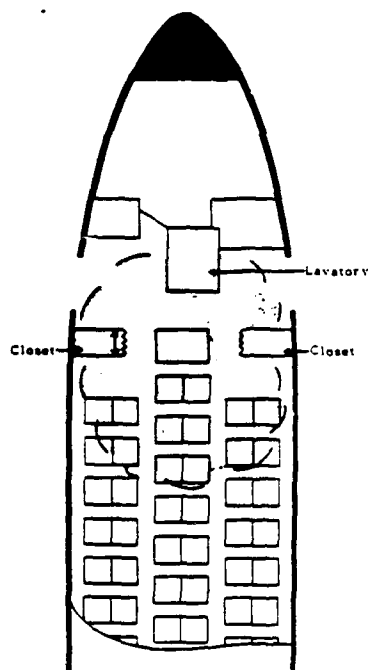
FIGURE 11C. SMOKE IN PASSENGER CABIN
INCREASED BY OPENING/
CLOSING CLOSET DOOR
